**2016 Annual Groundwater
Monitoring Report**

Palermo Wellfield Superfund Site
Tumwater, Washington

April 21, 2017

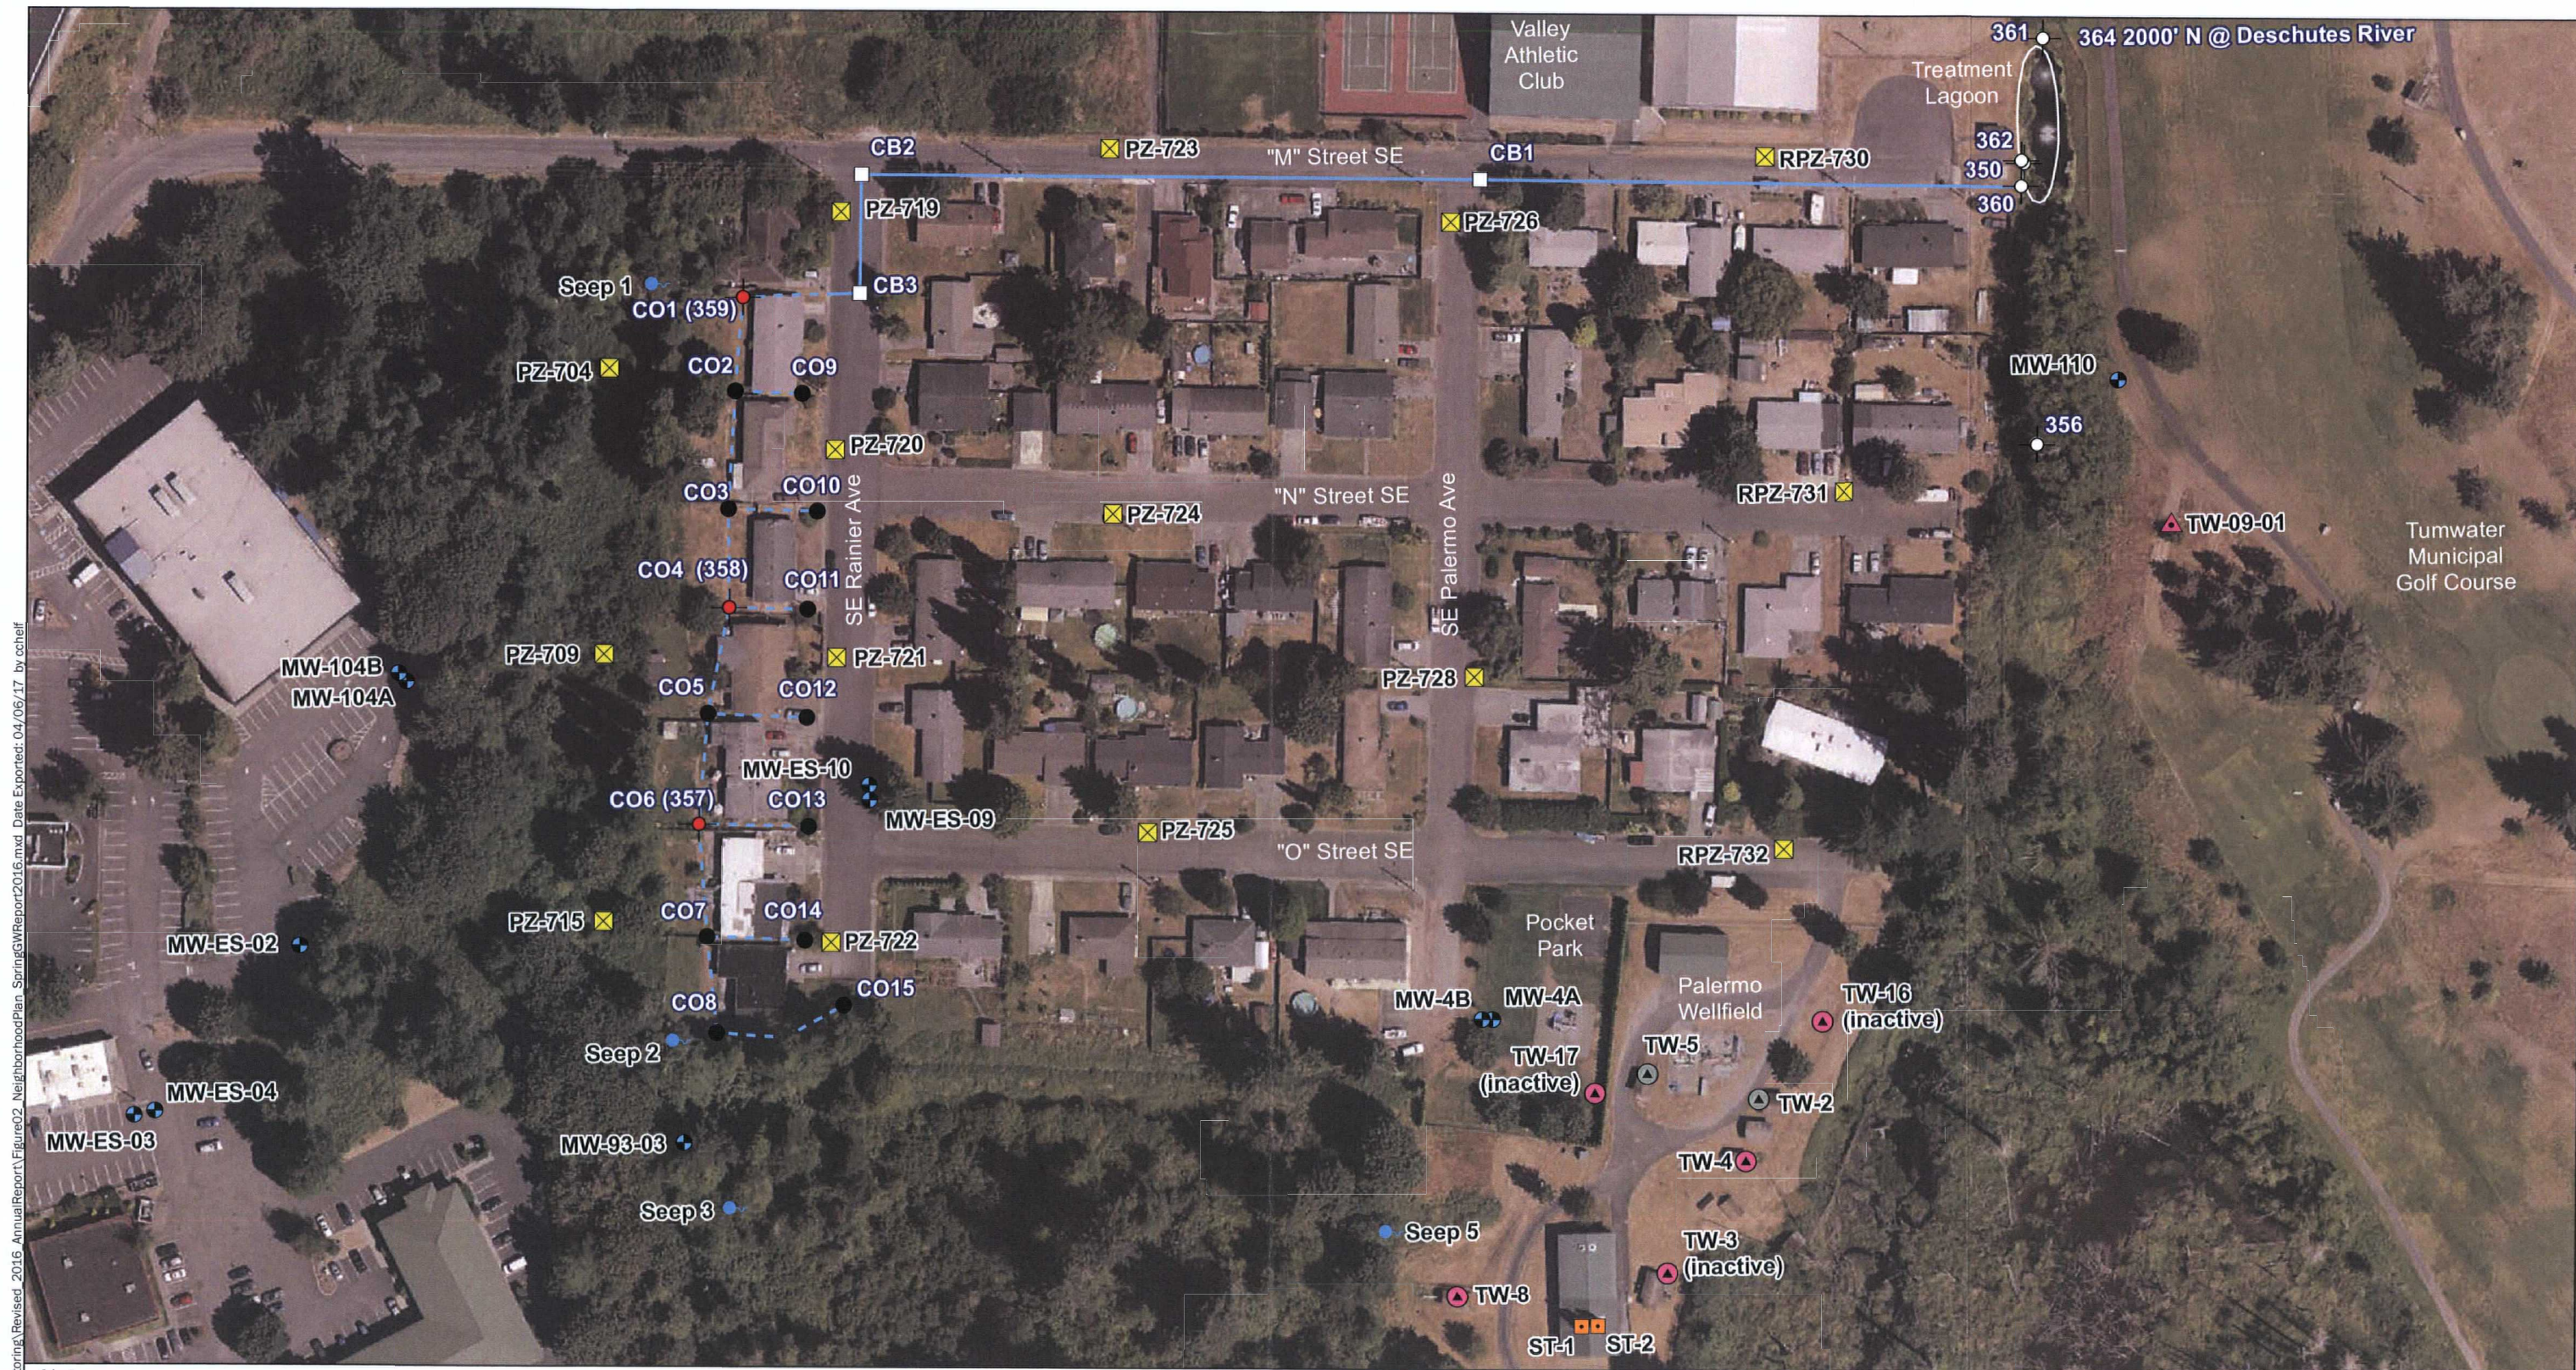
Palermo Neighborhood and Subdrain	
Palermo Wellfield Superfund Site	
	Figure 2

and remove PCE and TCE from the collected water (Figure 2). The subdrain system includes a subgrade perforated piping network installed behind the seven southern-most houses west of SE Rainier Avenue. The main perforated pipe or “trunk drain” is beneath the backyards of the houses. Groundwater that enters the perforated pipe flows to an unperforated “tightline” pipe beneath SE Rainier Avenue and M Street SE. The tightline pipe drains to a treatment lagoon located at the Municipal Golf Course. PCE and TCE are removed from the water by surface aeration before being discharged northward to the Deschutes River by way of an existing water course.

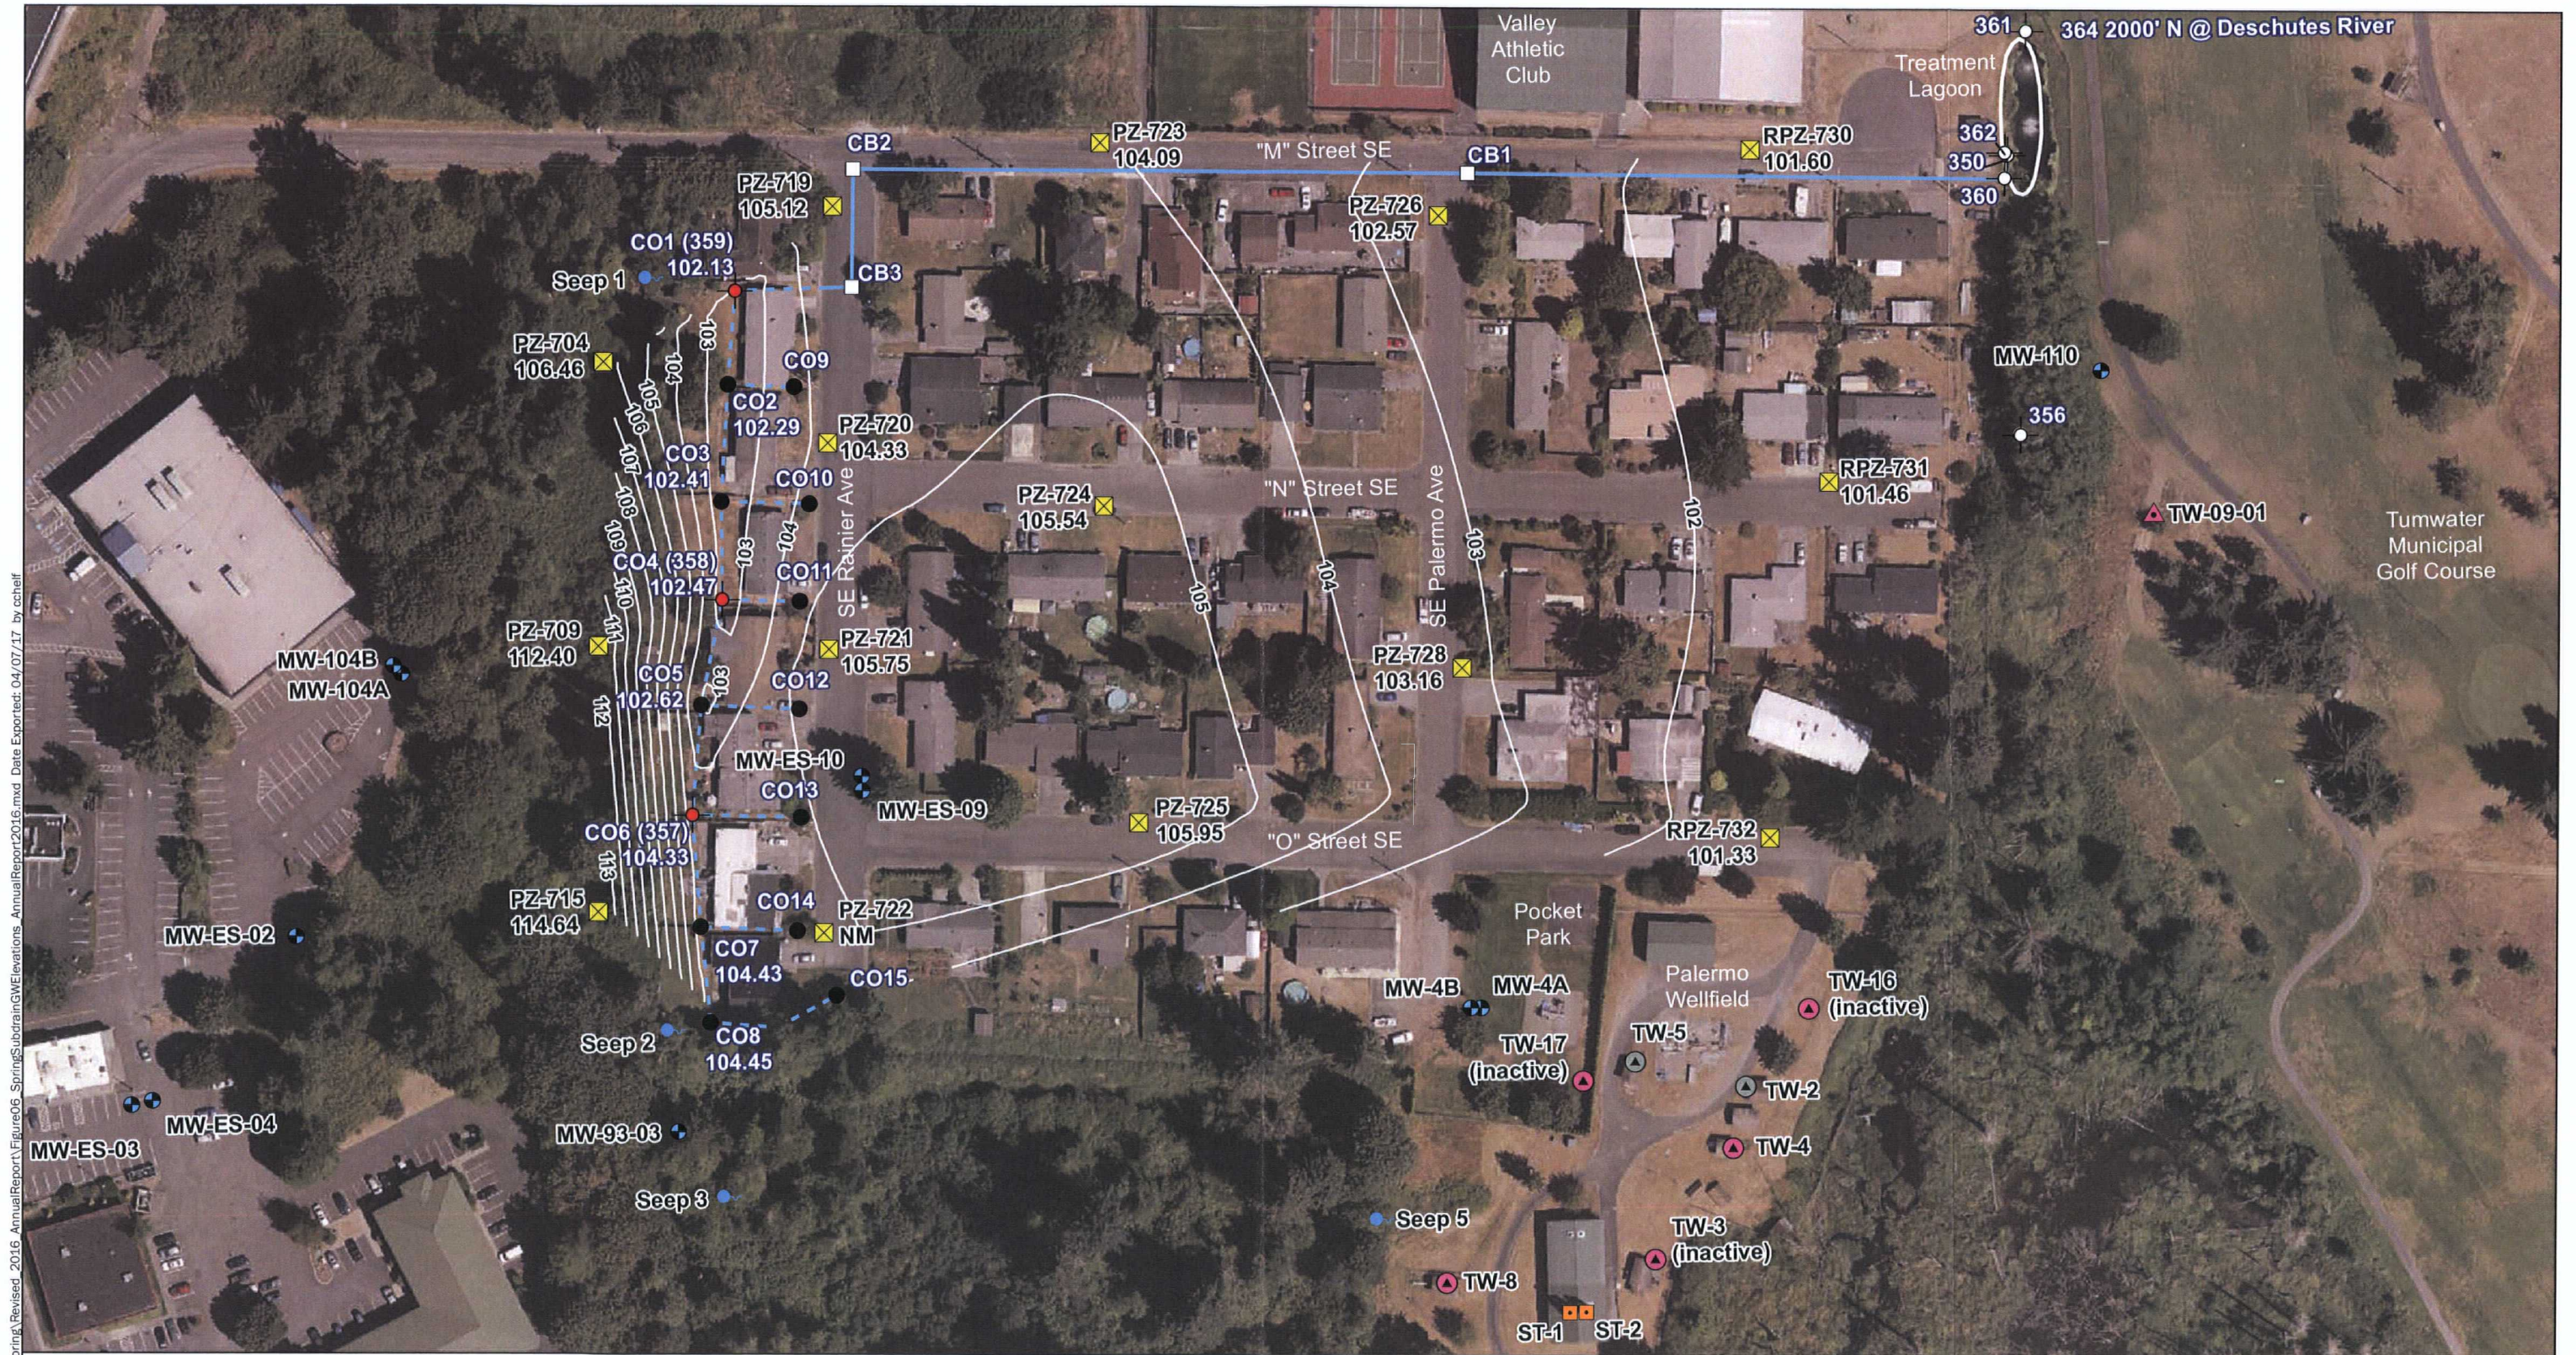
Spring 2016 - Palermo Neighborhood Shallow Groundwater Elevations

Notes:
1. Contours were generated using Surfer 8.0 (Golden Software) contouring software using the natural neighbor gridding method from water levels measured on April 18th and 26th, 2016.

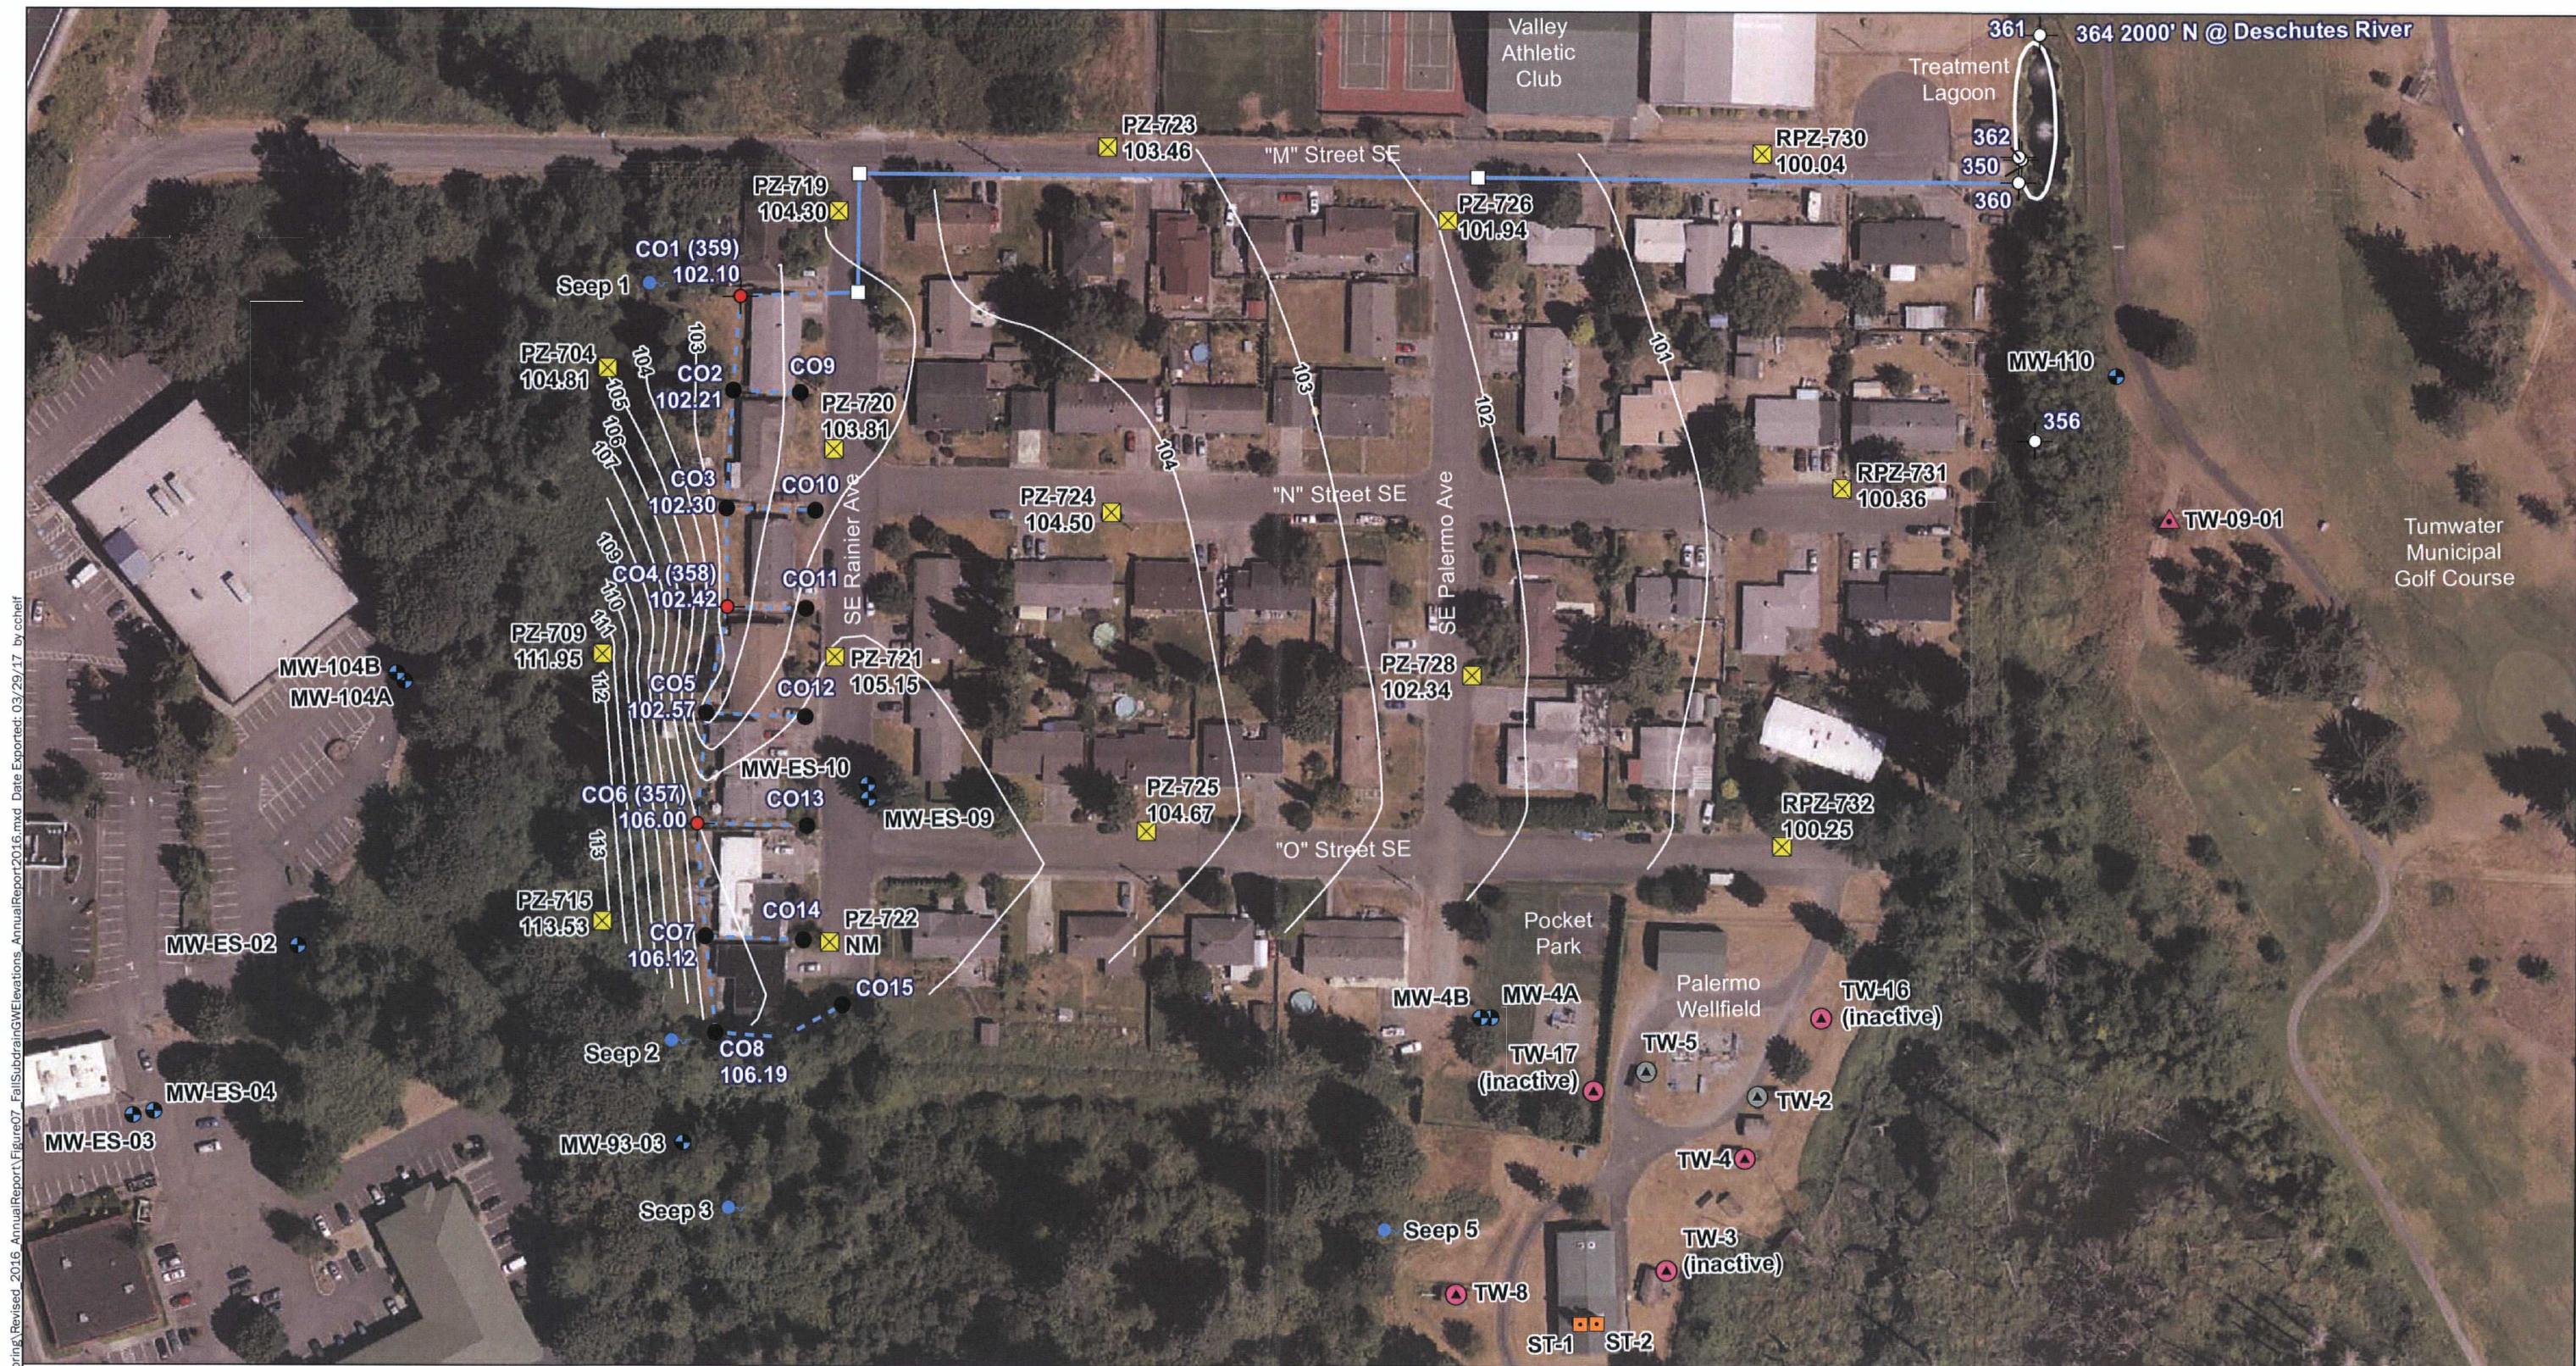
**Fall 2016 - Palermo Neighborhood
Shallow Groundwater Elevations**

1. Contours were generated using Surfer 8.0 (Golden Software) contouring software using the natural neighbor gridding method from water levels measured on August 29 and September 8, 2016.

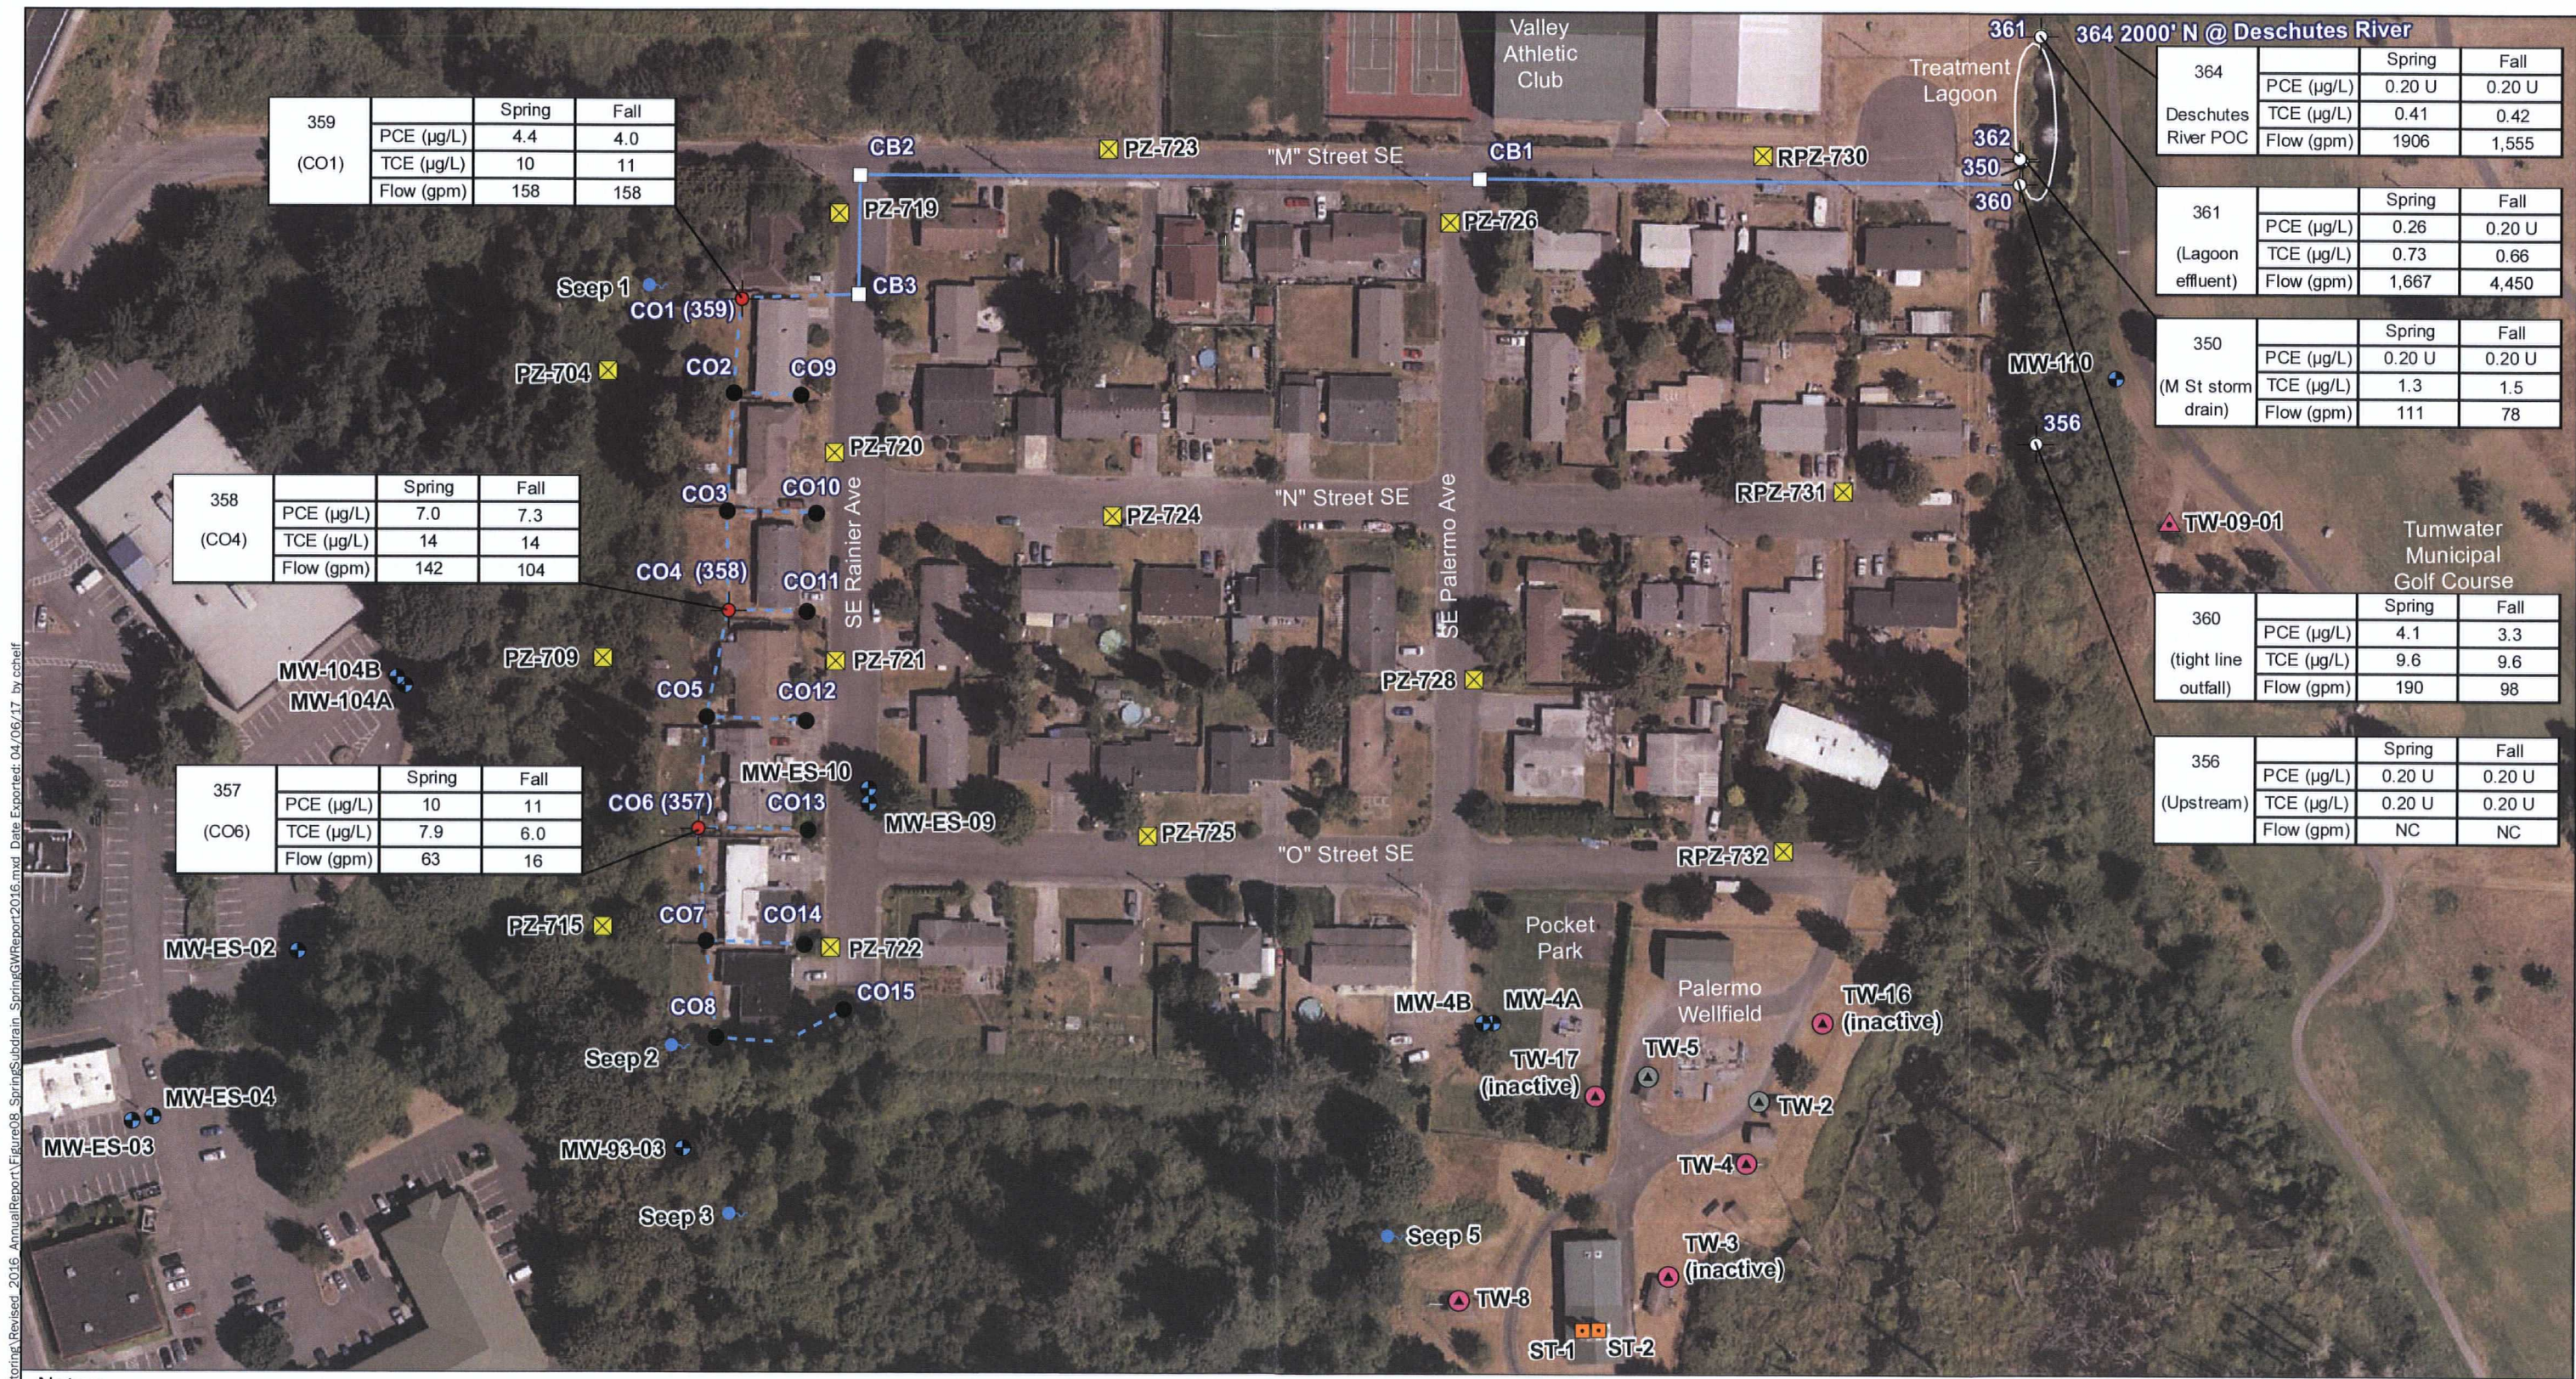
The highest concentrations of PCE in water samples collected from the subdrain during Fall 2016 were measured at Station 357 (CO-6) and the highest for TCE during the same period was at Station 358 (CO-4). Similar conditions were encountered during the Spring 2016 monitoring.

359 (CO1)		Spring	Fall
	PCE (µg/L)	4.4	4.0
	TCE (µg/L)	10	11
	Flow (gpm)	158	158

358 (CO4)		Spring	Fall
	PCE (µg/L)	7.0	7.3
	TCE (µg/L)	14	14
	Flow (gpm)	142	104
